# Manhole Inspection Summary

Manhole # S51II\_002MH

Insp Date: **8/5/08 11:36 AM**

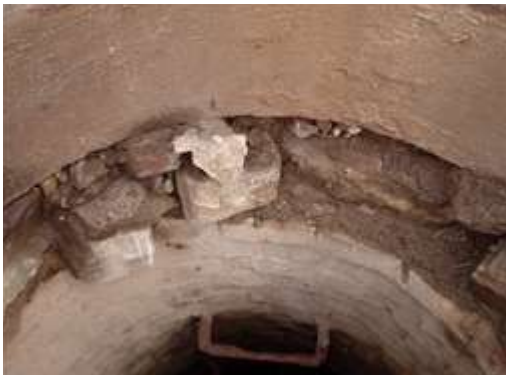
Defect 1

Condition: ☐ Sound ☐ Cracked ☐ Root Intrusion ☒ **Loose Brick** ☐ Deteriorated

Loose bricks

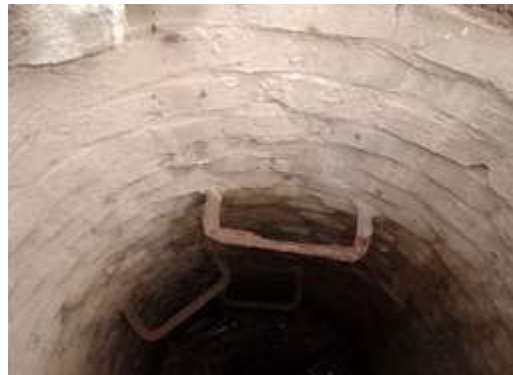
Defect 2

Infiltration: ☐ None ☐ Joint ☐ Cracks ☒ **Mortar** ☐ Roots ☐ Wall

Infiltration

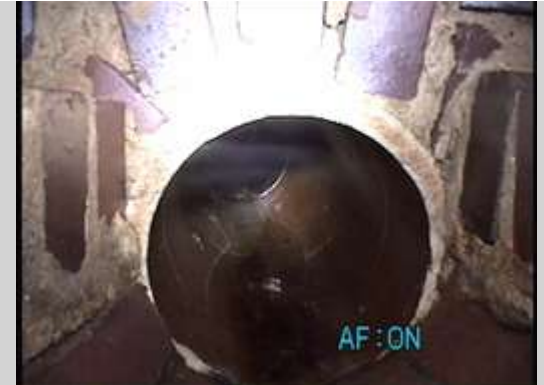
12 O'Clock Outflow

Pipe Height: **8.4** (in.) Rod and Bar (Angled)  
Pipe Material: **Clay** ☐ Pipe Lined  
Invert Depth: **14.00** (ft.) Flow Characteristics: **Slow**  
Deposits: ☒ None ☐ Mud ☐ Sludge ☐ Debris ☐ Grease  
Silt Depth: (in.) Deposits Extent:  
Infiltration: **None** Pipe Seal Cond: **Sound**

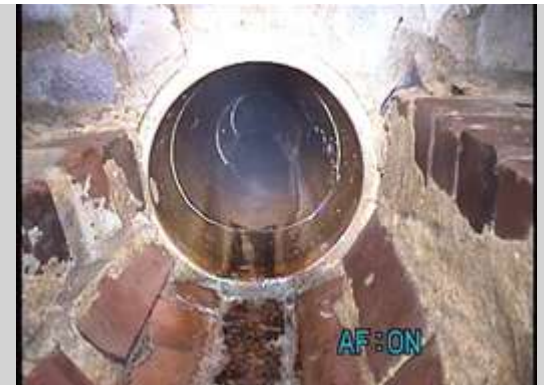
3 O'Clock Inflow

Pipe Height: **8.4** (in.) Rod and Bar (Angled)  
Pipe Material: **Clay** ☐ Pipe Lined  
Invert Depth: **13.20** (ft.) Flow Characteristics: **Slow**  
Deposits: ☒ None ☐ Mud ☐ Sludge ☐ Debris ☐ Grease  
Silt Depth: (in.) Deposits Extent:  
Infiltration: **None** Pipe Seal Cond: **Sound**

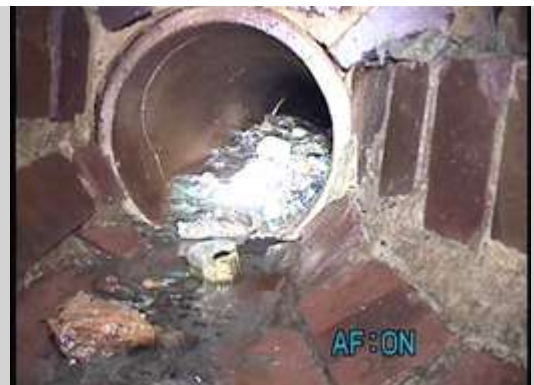
9 O'Clock Inflow

Infiltration: **None** Pipe Seal Cond: **Sound**
